Bantam Lake 2018

Some of what we learned in 2017

*Northeast Aquatic
Research*

March 15, 2018

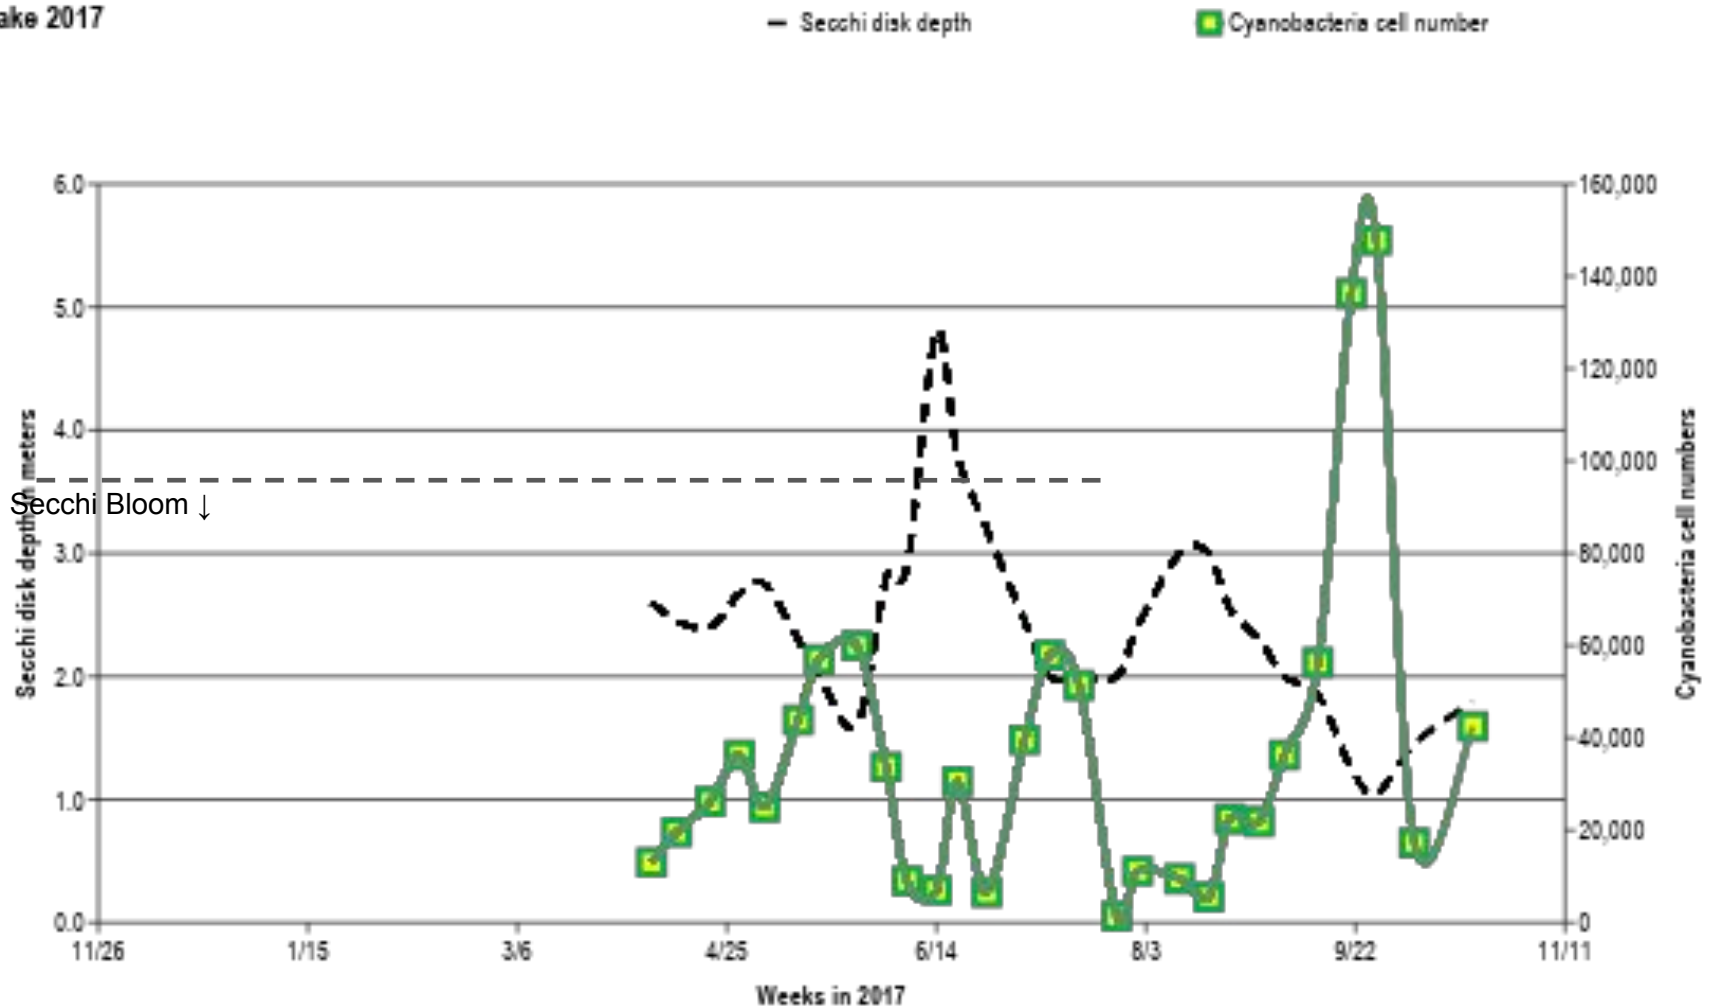
Trend in Secchi disk depth and Cyanobacteria numbers

Bantam Lake 2017

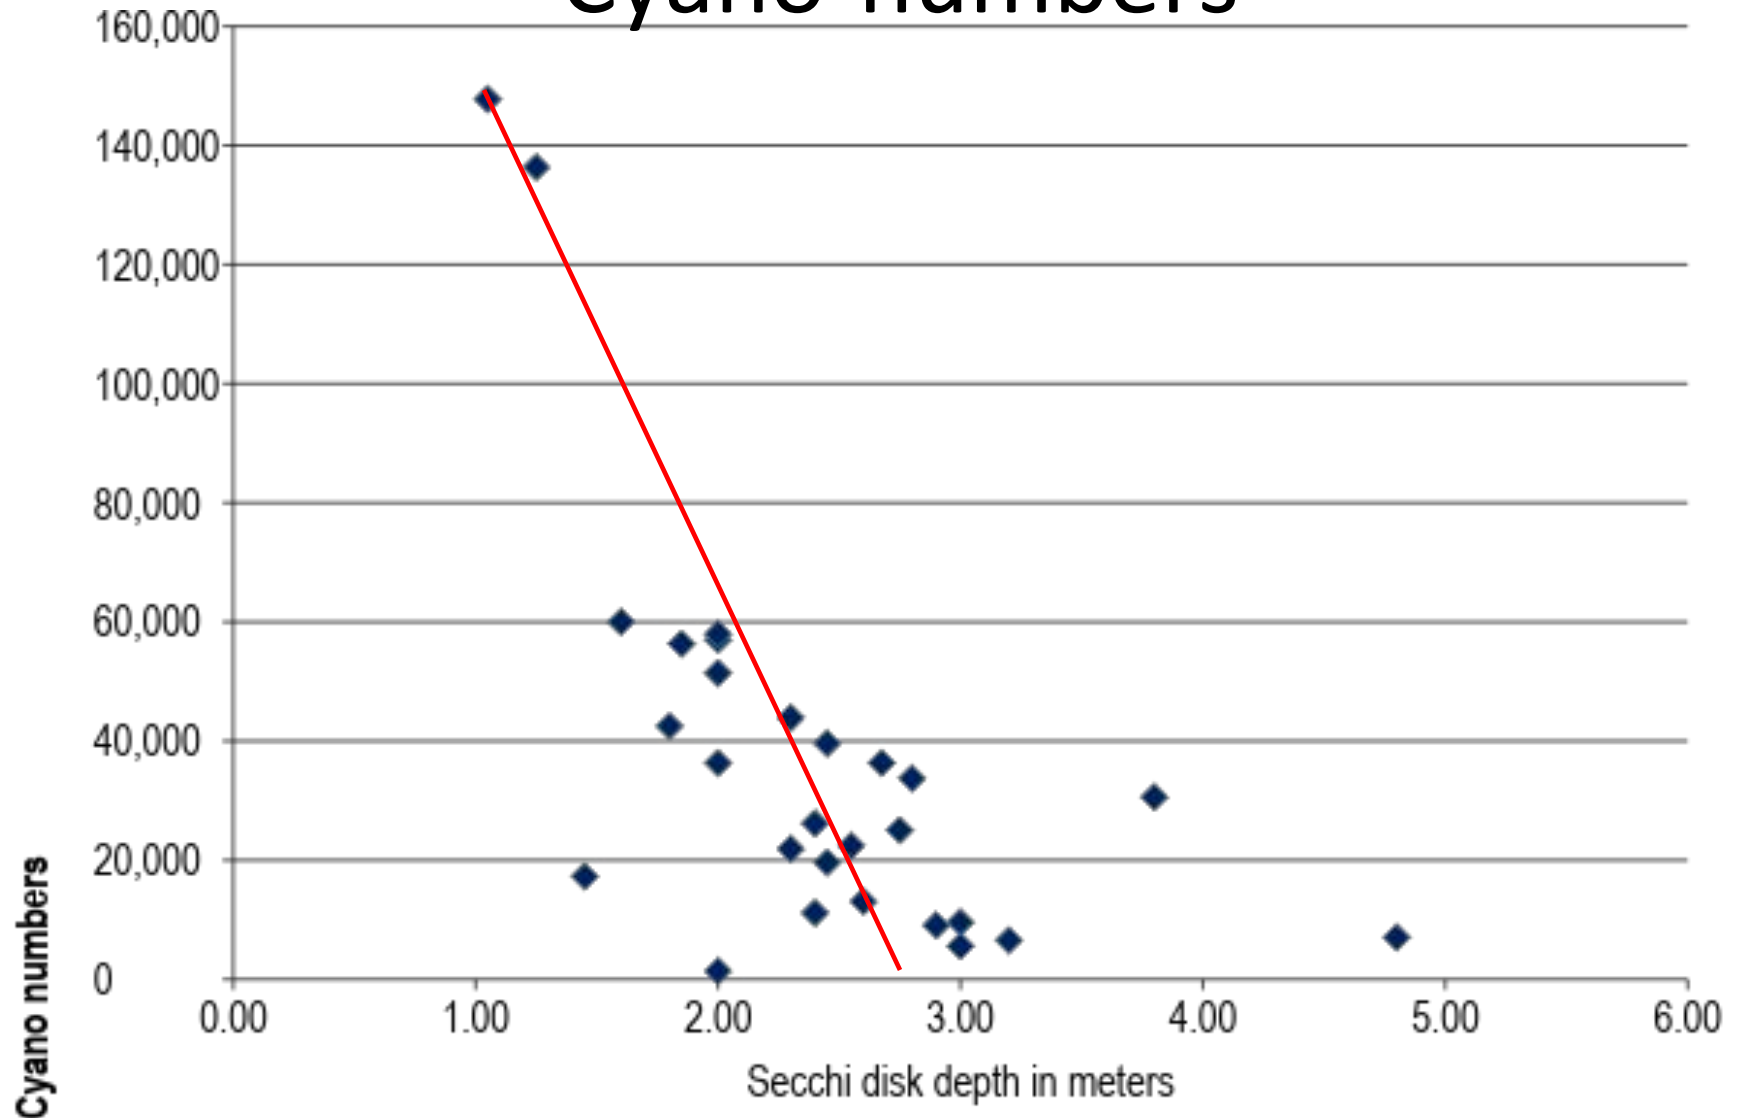
Relationship between water clarity and Cyano-numbers

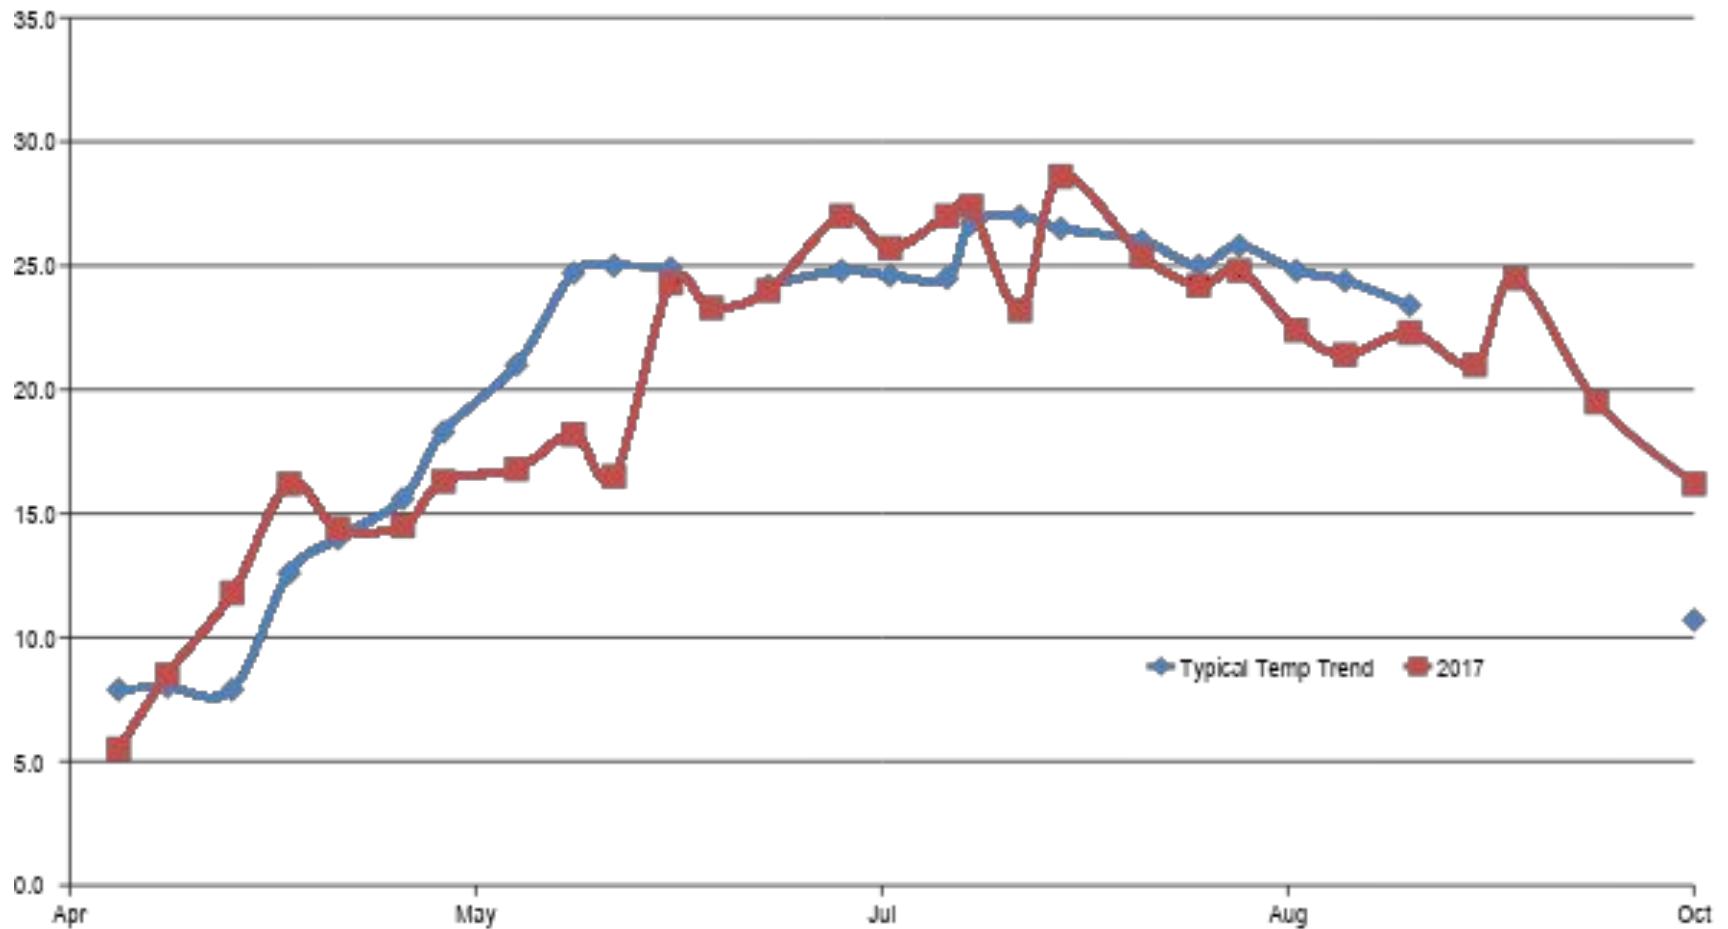
Trend in surface water temperatures

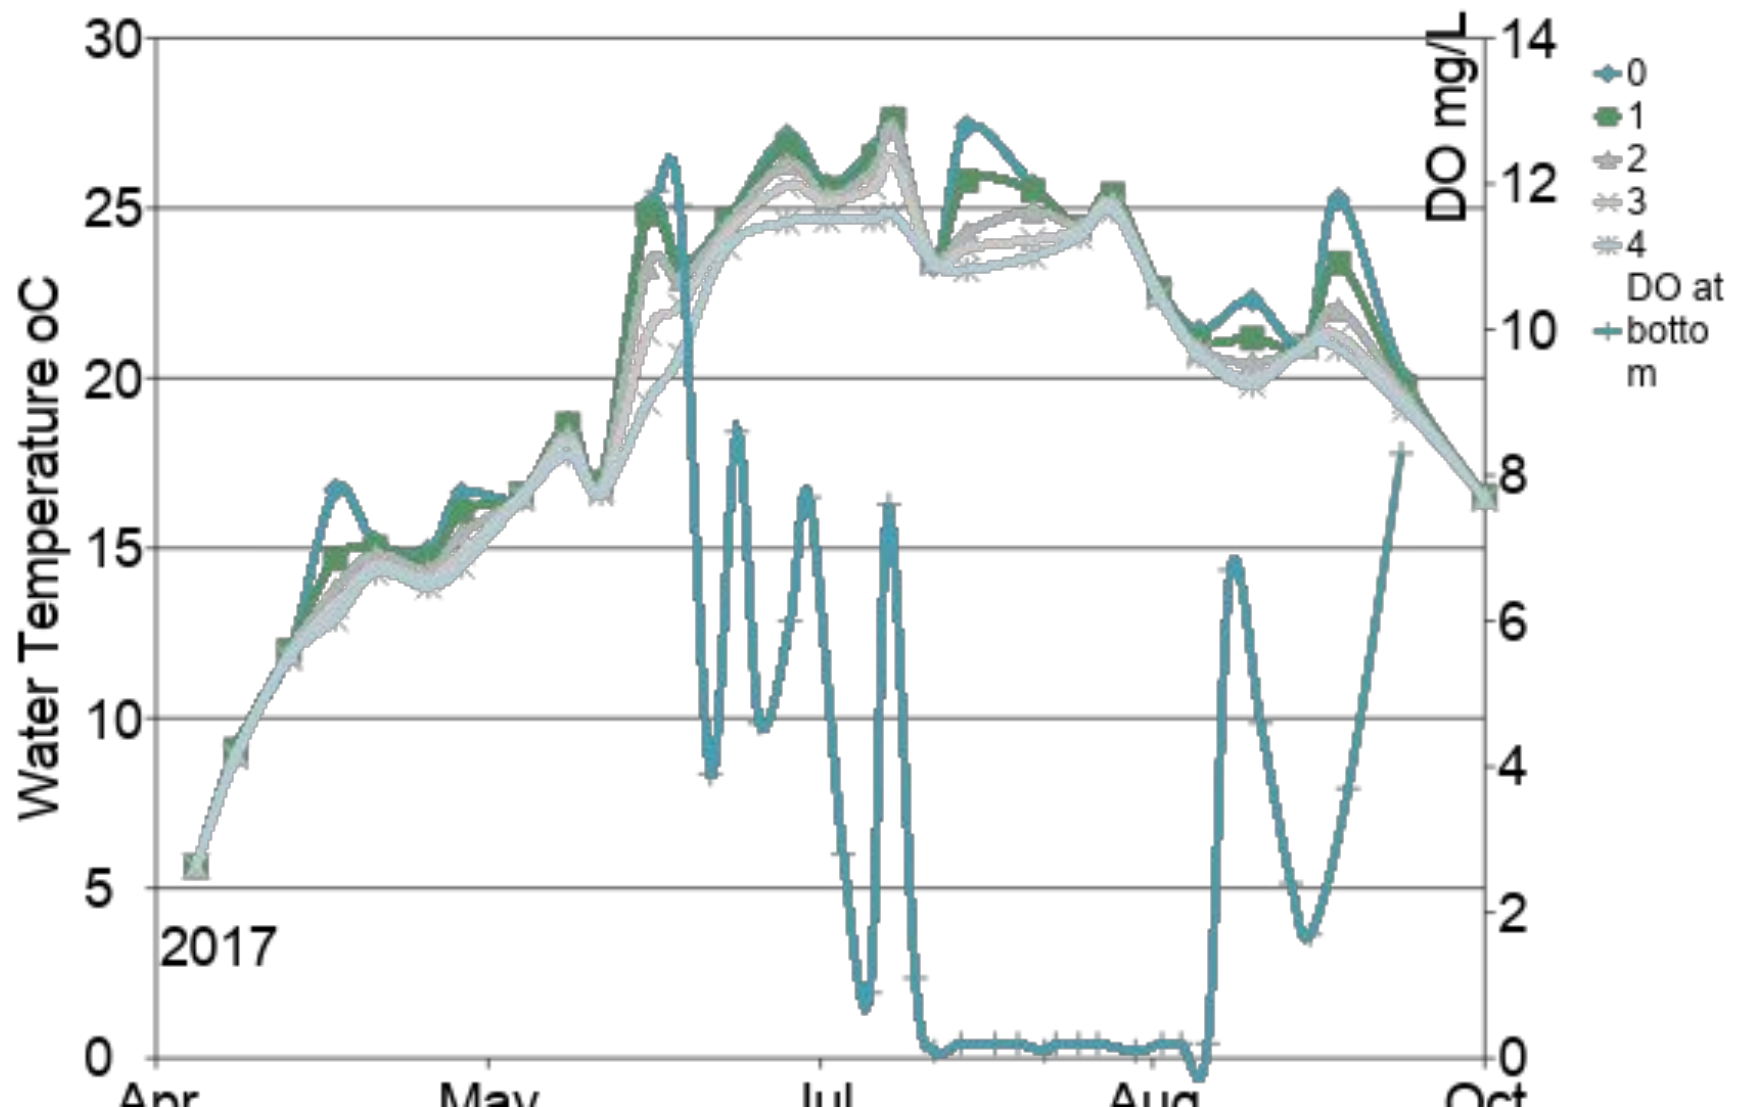
Water temperature and DO

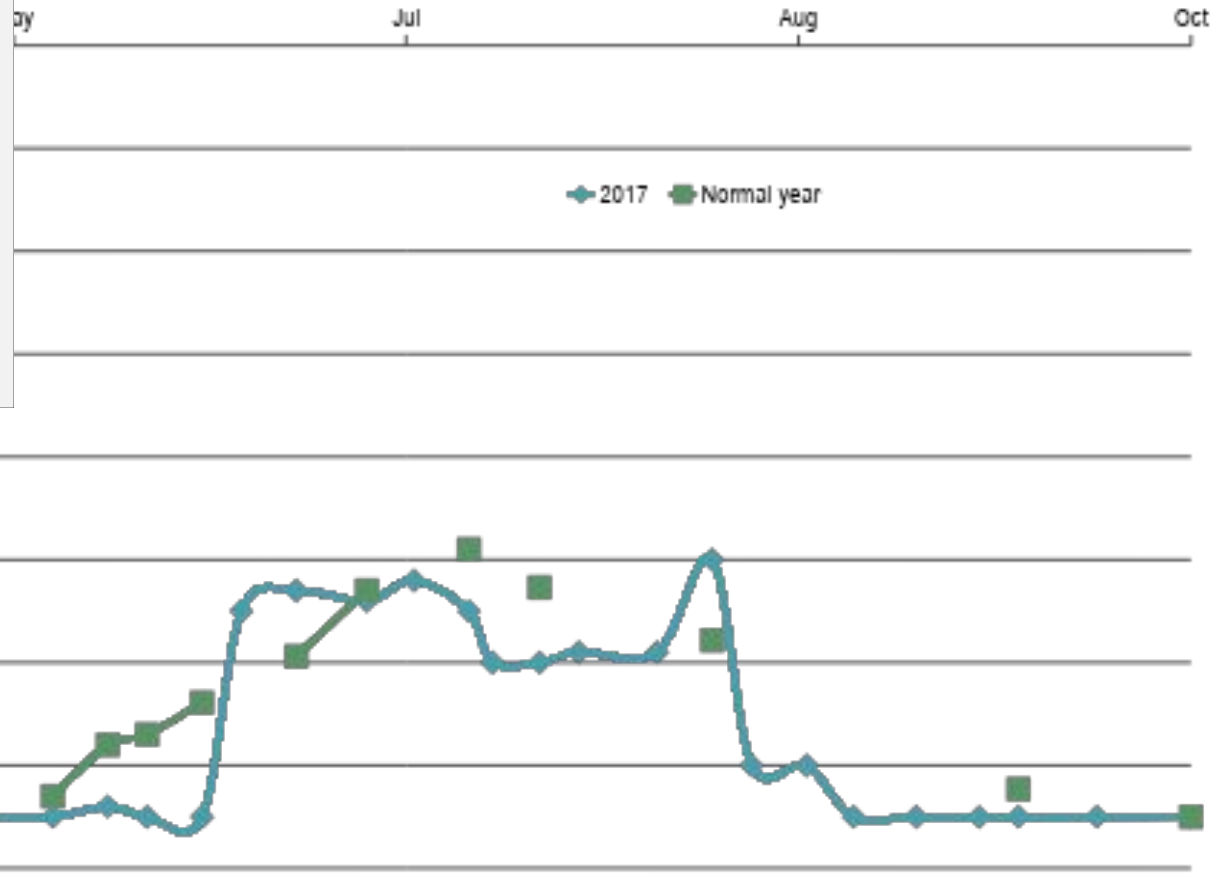
Trends in Anoxic Boundary

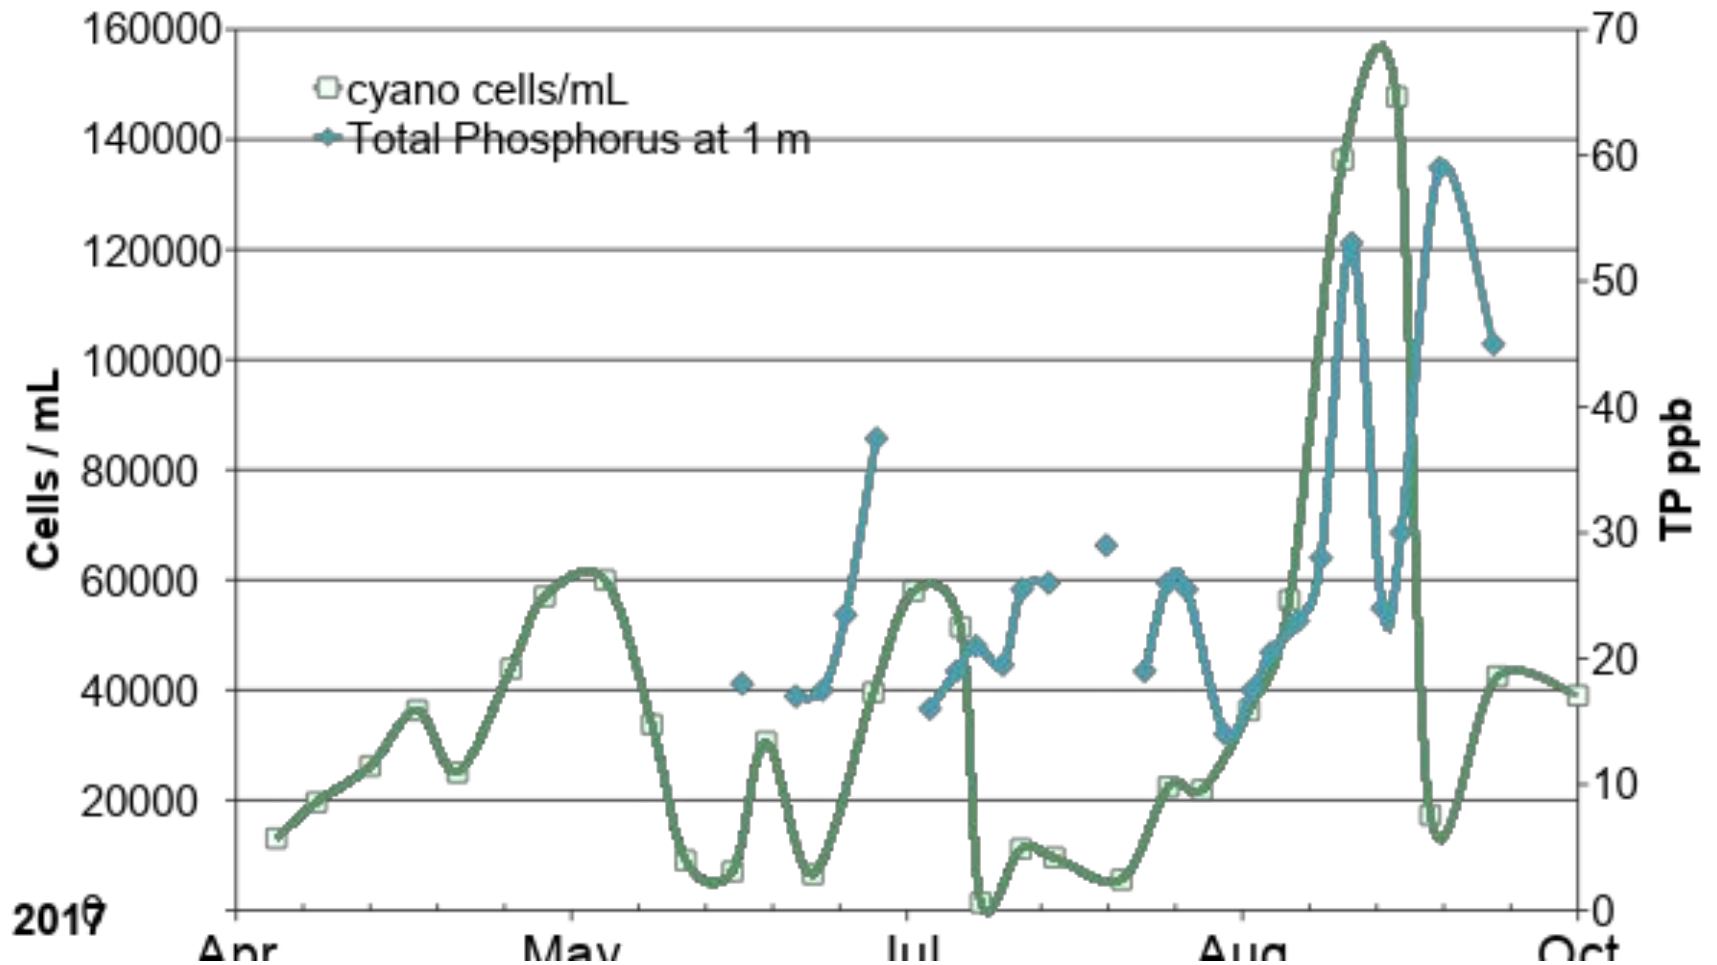
TP and Cyano numbers

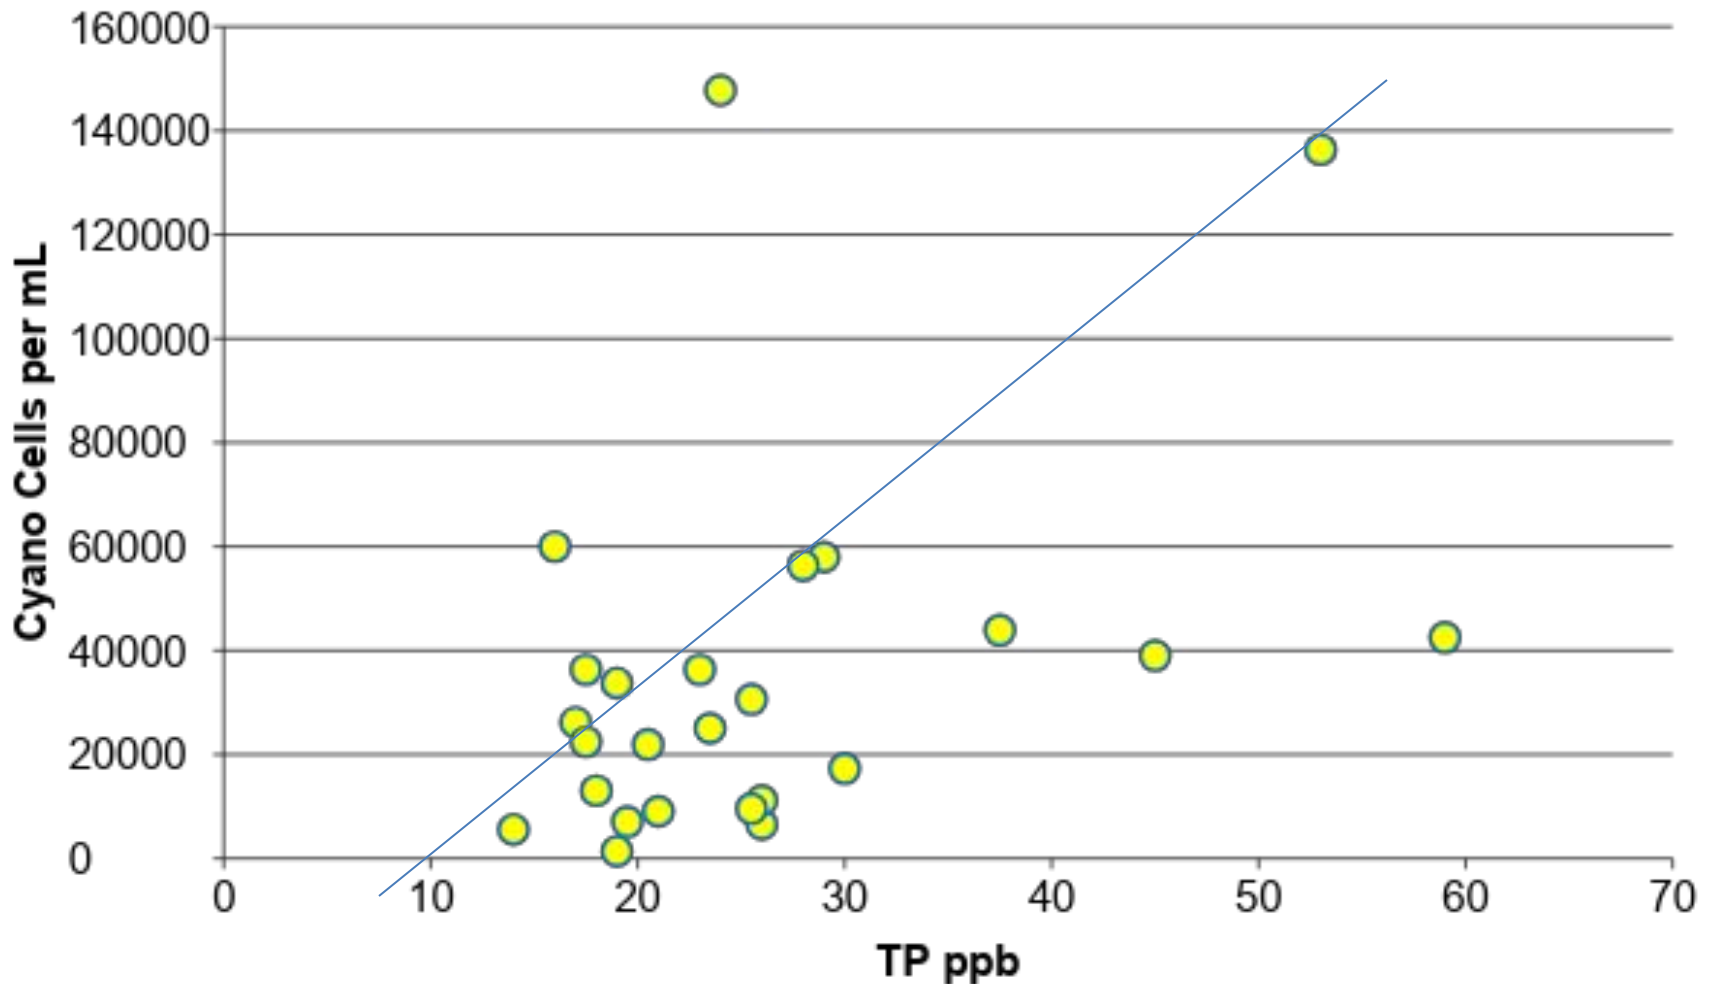
Total phosphorus and Cyanobacteria numbers in 2017
